Introduction

This information sheet outlines reasonable owner expectations for an onsite sanded and finished timber floor. This includes solid T&G flooring, parquetry and other flooring types that have been sanded and finished onsite or recoated. Concerning this, there are performance aspects of the floor which generally relate to fixing integrity, board shape and movement, and then there are appearance aspects which focus more on the sanding and finishing.

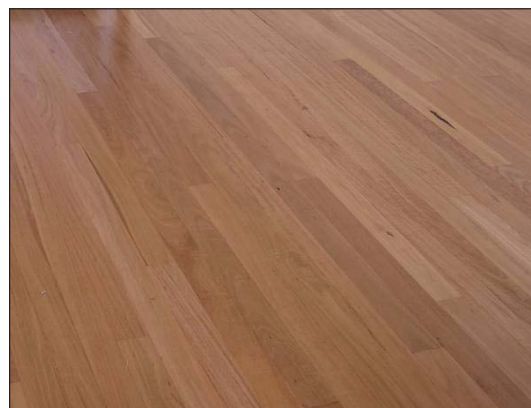
A select grade Blackbutt floor where the backsawn gum vein toward the top right exceeds grade limits but is acceptable within the floor.
