## Introduction

## The concrete slab and adhesive fixed floors

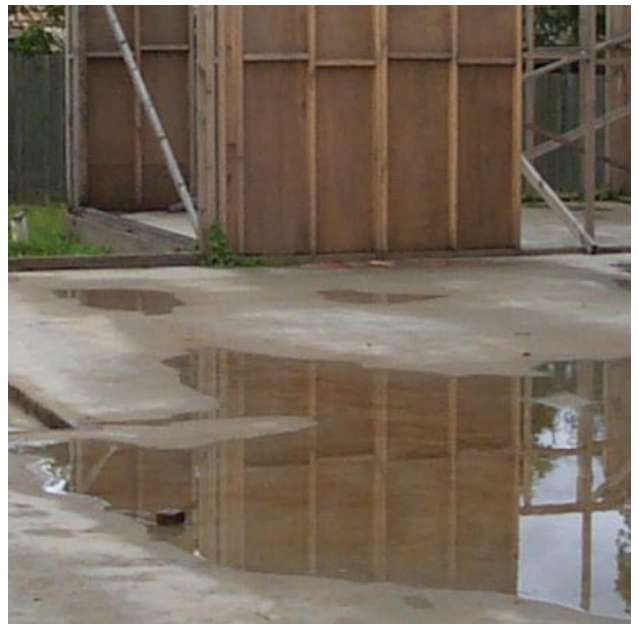
Concrete slabs are finished with trowelling machines sometimes referred to as helicopters. These machines create a very smooth surface, however slight undulation of say 3 to 5 mm are present. The variations are normally not visible by looking at the slab but can be seen soon after completion or after rain when small puddles are visible. Timber flooring adhesive manufacturers allow for these slight variations by recommending the use of notched application tools that provide an adhesive height that is normally 5mm or greater. This ensures that when adhesive is correctly spread, low spots in slabs have sufficient adhesive. Some adhesives are also of the foaming type and the expansion of the adhesive during the curing helps to provide a consistent adhesive layer between the slab and board. Enough adhesive is generally spread to cover 3 or so rows of boards and adhesive is generally spread at 90 degree to the direction

of the flooring being laid. Flooring is bedded in place and pinned or weighted down until the adhesive is fully cured. Timber flooring adhesives used in direct fix applications are generally moisture curing polyurethanes and these remain with some degree of flexibility, allowing the floor to expand and contract during seasonal relative humidity variations.

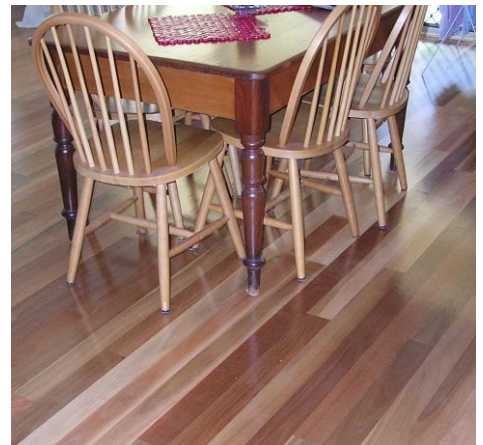
The occasional drummy board in a floor, with up to about 25% of the board area sounding hollow, are not considered a concern provided there is no vertical movement at board edges. In such instances there is no need to do anything about them. However in some instances where hollow sounds are extensive over the floor or a group of adjacent boards are drummy, this can indicate poor adhesion which may be associated with the fixing of a timber flooring or sub-floor. Where drummy sounds are more localised and there is vertical movement under foot pressure, then this too requires further investigation. In such instances the adhesive bond is likely to have been compromised and remedial work is likely to be necessary. This may only necessitate some small holes being drilled through the boards and injecting an adhesive, however in severe cases board replacement may be necessary. Where more extensive work is required aspects such as the provision of adequate expansion allowance, the condition of the sub-floor and any possible effects from moisture ingress should be checked.
